# **Intel® 82571EB/82572EI Ethernet Controller**

**Specification Update**

*January 2012*  
*Revision 6.5*

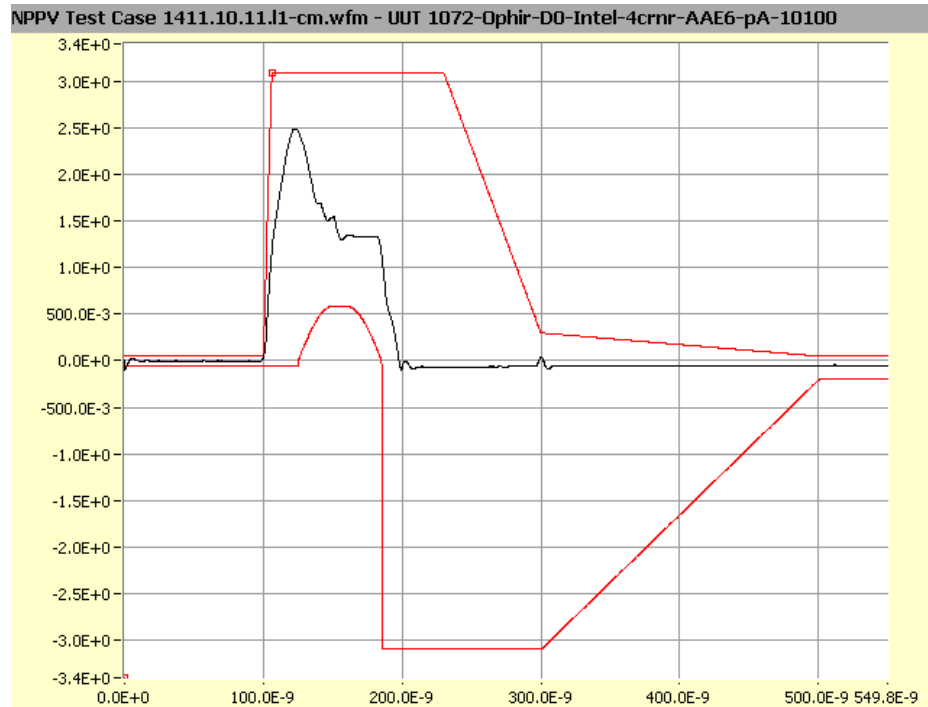
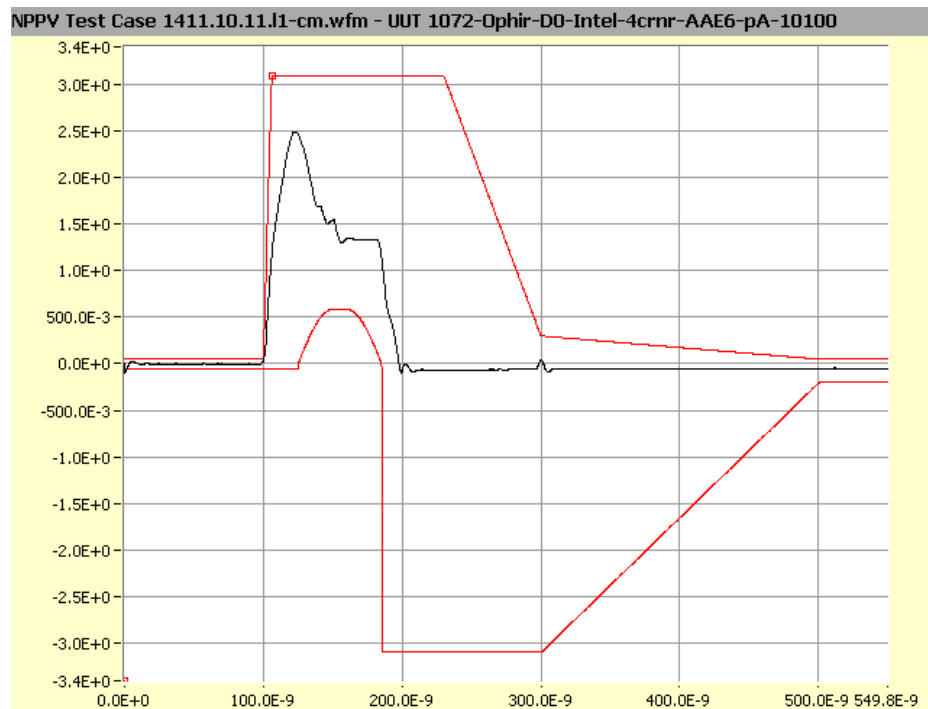
## 27. 10base-T Link Pulse Hits the Template Mask Due to Voltage Ripple/Glitch.

Problem: The 10base-T link pulse touches the template due to voltage ripple/glitch.

Implication: Compliance with the specification is not complete, however, there is no effect at system level.

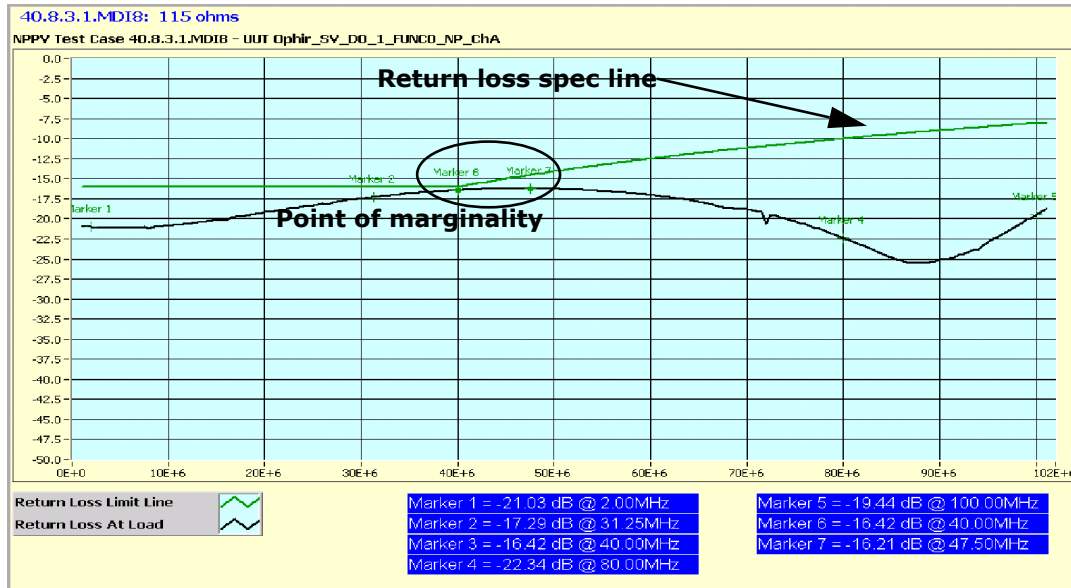
Clarification: Return loss for 115 ohm load is marginal (Gigabit IEEE specification Section 40.8.3.1) near the frequency of 40MHz. Return loss is acceptable throughout the rest of the frequency spectrum and conforms to the 10Base-T and 100Base-TX specification limits.

IEEE conformance is marginal. There is no impact on system-level performance.
