*TMS320DM365*  
*Digital Media System-on-Chip (DMSoC)*  
**Silicon Revision 1.1 and 1.2**

## **Silicon Errata**

Literature Number: SPRZ294E  
March 2009—Revised July 2011

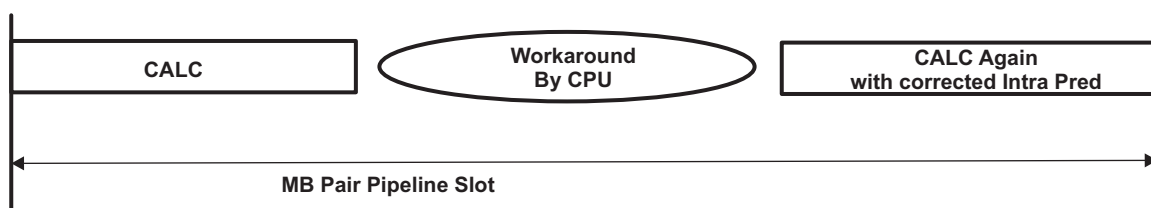
**Figure 3. MB Pair Pipeline Slot Example**

**Details:** During the calculation of the intra prediction block, pixel values can reach 512 or higher. However, the computation engine has precision only enough to hold values equal to 511 or less.

- In Encode, an incorrect (but legal) bitstream will be generated, and a mismatch will happen between the Encoder and Decoder resulting in significant quality degradation.
- In Decode, the reconstructed macroblock will be incorrect.
- If the following MBs are intra referring to this MB, the error is propagated spatially within the picture.
- If the following pictures refer to this MB, the error is propagated temporally to the following pictures.

During a MB pipeline slot, a CALC is done, a workaround by CPU, and CALC again with corrected intra prediction macroblock (see [Figure 3](#)).

If the MB is of intra 16x16 plane mode, perform the following steps:

1. Let CALC run.
2. Wait for CALC to complete
3. After CALC completes, switch BFSW for iprdbuf : CALC → DMA
4. Check and correct Intra Prediction (for more details, see the *Check and Correct Intra Prediction* section below)
5. Switch BFSW for iprdbuf : DMA → CALC
6. Switch BFSW for calcmdbuf : CALC → DMA
7. Set up CALC commands with intra mode for IQ/IT and inter mode for prediction (for more details, see the *Set up CALC Commands with Intra mode for IQ/IT and Inter Mode for Prediction* section below)
8. If MBAFF, retrigger DMA for upper row data
9. Switch BFSW for calcmdbuf : DMA → CALC
10. Switch BFSW for reconbuf : LPF → DMA
11. Read left reconstructed column
12. Switch BFSW for reconbuf : DMA → LPF
13. Switch BFSW for calcsbuf : CALC → DMA
14. Set back left reconstructed column
15. Switch BFSW for calcsbuf : DMA → CALC
16. Re-run CALC
17. Wait for CALC to complete
