ES_LPC1850/30/20/10

Errata sheet LPC1850, LPC1830, LPC1820, LPC1810

Rev. 6.1 — 22 November 2013

Errata sheet

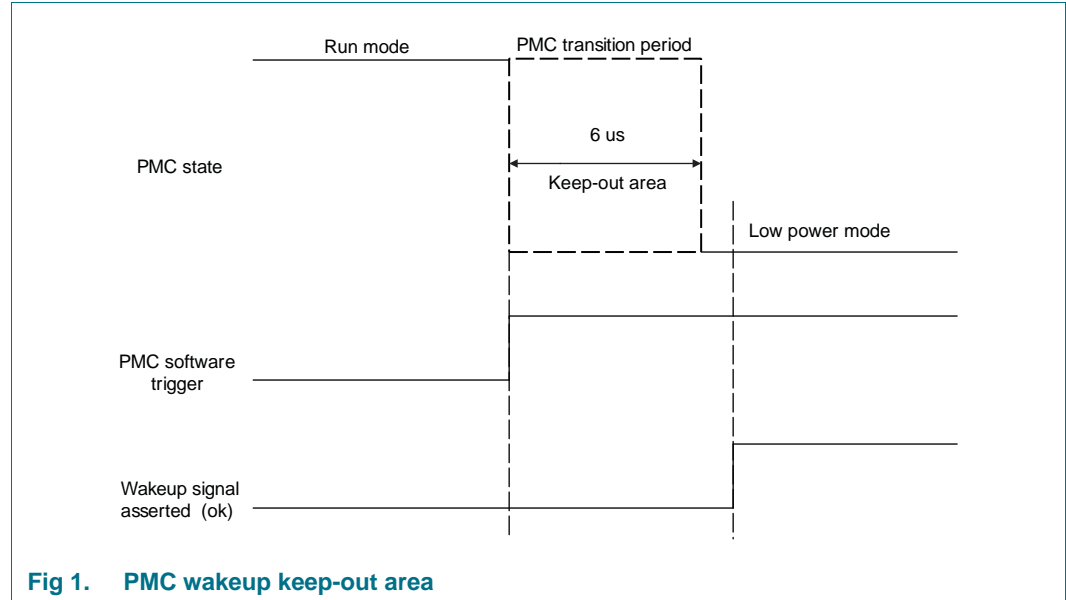
Fig 1. PMC wakeup keep-out area

When the chip is in a transition from active to Deep Sleep, Power Down, or Deep Power Down, wakeup events are not captured and they will block further wakeup events from propagating. The time window for this transition is 6 μ S and is not affected by the chip clock speed. After a wakeup event is received during the PMC transition, the chip can only recover by using an external hardware reset or by cycling power.

Make sure that a wakeup signal is not received during the Deep Sleep, Power Down, or Deep Power Down transition period. An example circuit to work around this could include an external 6 μ S one shot which could be triggered via software using a GPIO line when entering Deep Sleep, Power Down, or Deep Power Down mode. The one-shot's output could be used to gate the wakeup signal(s) to prevent receiving a wakeup signal during the PMC transition period. Depending on the system design, it may also be needed to latch the wakeup signal(s) so that they will still be present after the one-shot's 6 μ S timeout.

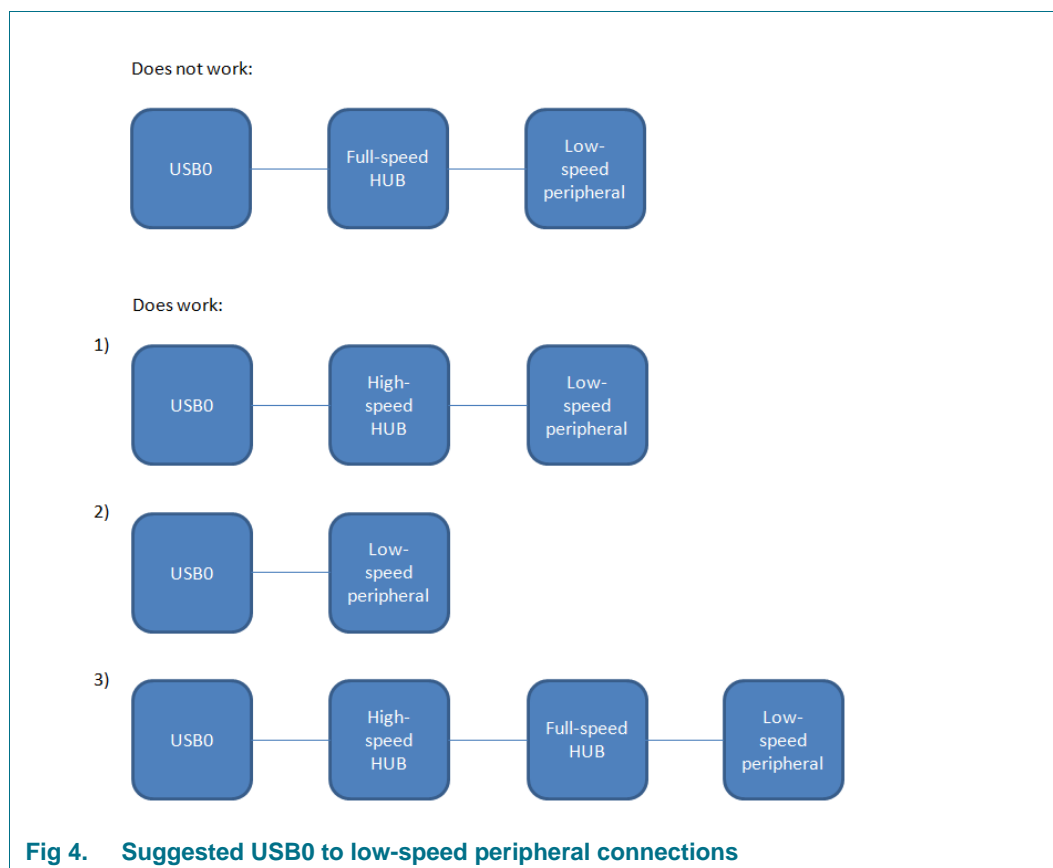
The USB controller called USB0 is unable to communicate with a low-speed USB peripheral in host mode when there is a full-speed hub directly connected to the USB0 port and a low-speed peripheral is connected in the tree somewhere below this full-speed hub. Only USB0 has this problem; the other USB controller, USB1 does not.

There is no work-around for this problem. It is suggested that the low-speed USB peripheral is either connected directly to USB0 or a high-speed hub is placed between that peripheral and USB0.
