ES_LPC177x/8x Errata sheet LPC177x/8x Rev. 3.4 — 26 November 2013

Errata sheet

Info	Content
Keywords	LPC1788FBD208, LPC1788FET208, LPC1788FET180, LPC1788FBD144, LPC1787FBD208, LPC1786FBD208, LPC1785FBD208, LPC1778FBD208, LPC1778FET208, LPC1778FET180, LPC1778FBD144, LPC1777FBD208, LPC1776FBD208, LPC1776FET180, LPC1774FBD208, LPC1774FBD144, LPC177x/8x errata
Abstract	This errata sheet describes both the known functional problems and any deviations from the electrical specifications known at the release date of this document.
	Each deviation is assigned a number and its history is tracked in a table at the end of the document.

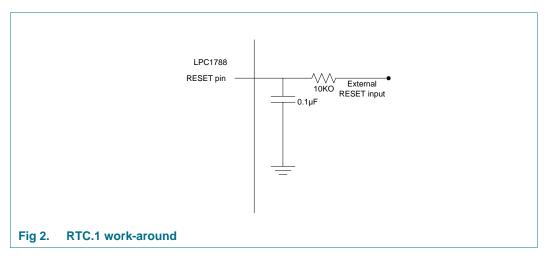
RTC temporarily pauses and loses fractions of a second during the rising and falling edges of RESET. This occurs only in the LQFP packages with certain voltage swings and ramp rates. The problem is exacerbated by low temperatures. Reducing the voltage swing and/or ramp rate of the reset pulse will eliminate this loss of time counts. When this issue occurs, the impact on RTC accuracy is expected to be one second every several thousand reset events.

Adding an RC filter between the reset pin and the external reset input to control the reset signal voltage ramp rate can prevent this problem.
