# **OMAP5912**

## **Applications Processor**

### **Silicon Errata**

SPRZ209K  
December 2003 – Revised December 2007

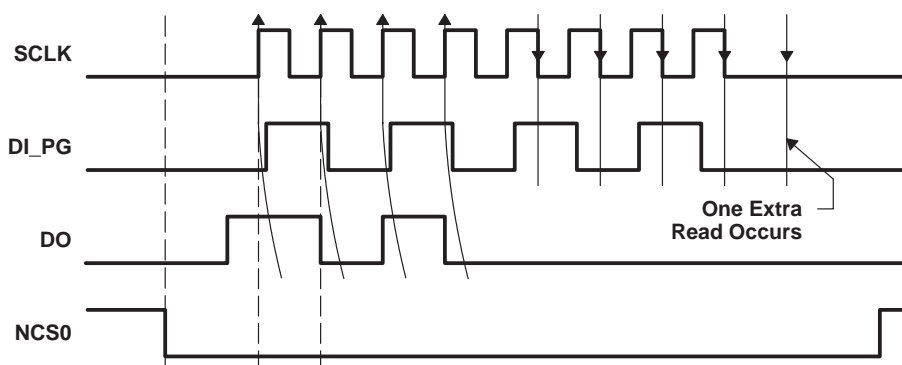
**Figure 5. Write (4 Bits) on Rising/Read (4 Bits) on Falling (TX = 0xA, RX and 0x1F = 0x14)**

**Advisory  
UWIRE\_1***MICROWIRE Interface RX Data Failures Possible***Revision(s) Affected:** All revisions**Details:** See the table below and Figure 5 and Figure 6.

| | <b>CSx_EDGE_RD = 0<br/>CSx_EDGE_WR = 0</b> | <b>CSx_EDGE_RD = 1<br/>CSx_EDGE_WR = 1</b> | <b>CSx_EDGE_RD = 0<br/>CSx_EDGE_WR = 1</b> | <b>CSx_EDGE_RD = 1<br/>CSx_EDGE_WR = 0</b> |
|---|---|---|---|--|
| <b>SCLK Inverted</b> | <p>Data read on rising edge of SCLK. Data write on rising edge of SCLK.</p> <p>Delay of 2 SCLK cycles between last bit transmitted on rising edge and first bit captured on rising edge.</p> <p>No issue.</p> | <p>Data read on falling edge of SCLK. Data write on falling edge of SCLK.</p> <p>Delay of 2 SCLK cycles between last bit transmitted on falling edge and first bit captured on falling edge.</p> <p>No issue.</p> | <p>Data read on rising edge of SCLK. Data write on falling edge of SCLK.</p> <p>Delay of 1.5 SCLK cycles between last bit transmitted on falling edge and first bit captured on rising edge.</p> <p><b>Issue found:</b><br/>One extra bit is captured.</p> <p><b>Workaround:</b><br/>Ignore Bit 0 of the receive data register (shift right one bit). Note that this workaround does not work for a 16-bit data configuration (1 bit is lost).</p> | <p>Data read on falling edge of SCLK. Data write on rising edge of SCLK.</p> <p>Delay of 2.5 SCLK cycles between last bit transmitted on rising edge and first bit captured on falling edge.</p> <p><b>Issue found:</b><br/>First bit captured will start 2.5 SCLK cycles after the last bit sent instead of 1.5 SCLK as defined in the specifications.</p> <p><b>Workaround:</b><br/>Do not use this configuration.</p> |

**Workaround:**

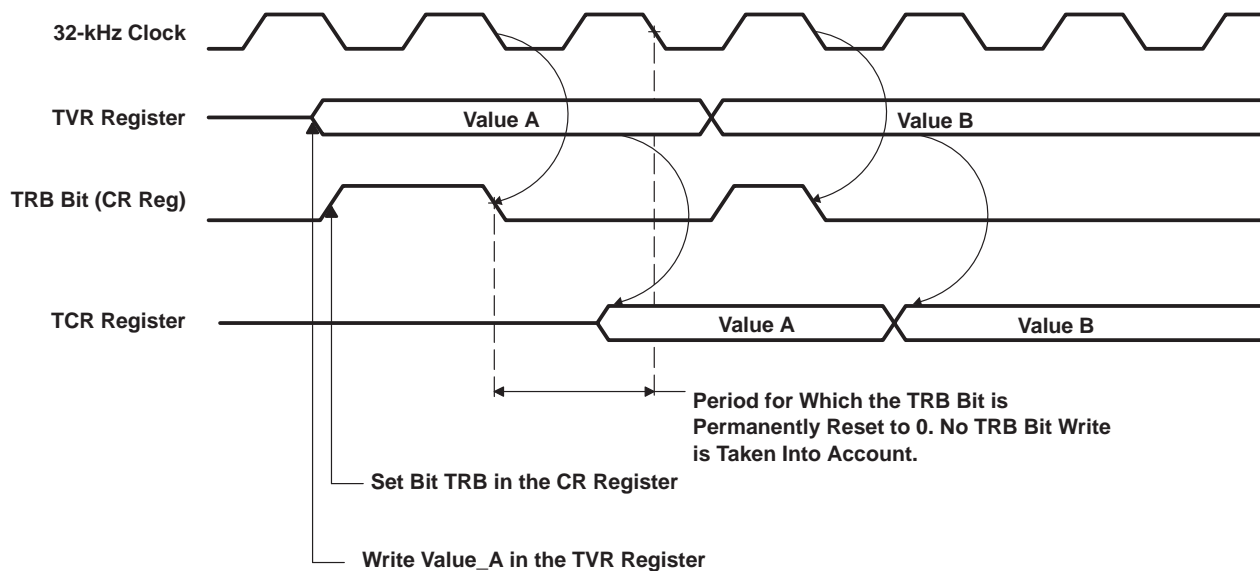
**Figure 11. TRB Timing Diagram**

**Details:** The Timer32K Reload Bit (TRB) is used to load the TCR register with the value contained in the TVR register. Once the TCR is loaded, the TRB bit should be automatically reset to '0'. The user should be able to use the TRB bit (by polling) to know when to load a new value in the TVR.

However (see Figure 11), the TRB bit is reset to zero by the falling edge of 32-kHz clock only after a maximum of  $1.5 \times 32\text{-kHz}$  clock period (or minimum  $0.5 \times 32\text{-kHz}$  clock period) after the TRB bit is set. The TCR register is loaded after a maximum of  $2 \times 32\text{-kHz}$  clock periods (or minimum of  $1 \times 32\text{-kHz}$  clock period) on the rising edge of the 32-kHz clock. After the TRB is reset, there is a one 32-kHz clock period where a new TRB setting will not be taken into account by the module. If the user programs the TVR and updates the TRB bit within this 32-kHz clock period, the new TVR will not be loaded correctly into the TCR.

**Workaround:** To load a new value into the TCR, poll the TRB bit. When the TRB is equal to '0' (signaling that the previous value has been loaded), the user has to wait for an additional one 32-kHz clock period, before loading a new value in the TVR and setting the TRB bit to '1'.

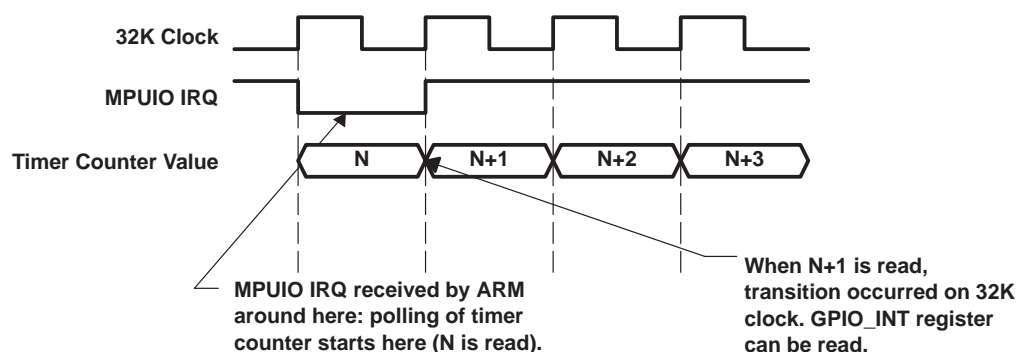
**Figure 12. Polling the Timer 32k Timer**

**Details:** The reset of the MPUIO GPIO interrupt is done asynchronously when a GPIO\_INT register read occurs. The release of this reset is done synchronously with the ARM\_XOR\_CLK when the 32-kHz clock is high. A read of the GPIO\_INT register while the 32-kHz clock is low or transitioning can result in a deadlock to the state machine that will cause all further interrupts subject to the MPUIO pin to be ignored.

**Workaround:** After receiving the MPUIO GPIO\_INT, the MPU should observe the 32-kHz clock and then read the GPIO\_INT register only just after a rising edge on the 32-kHz clock. There are different ways to detect a rising edge on the 32-kHz clock:

- Poll the timer 32k counter until there is an increment (see Figure 12, which describes the procedure)

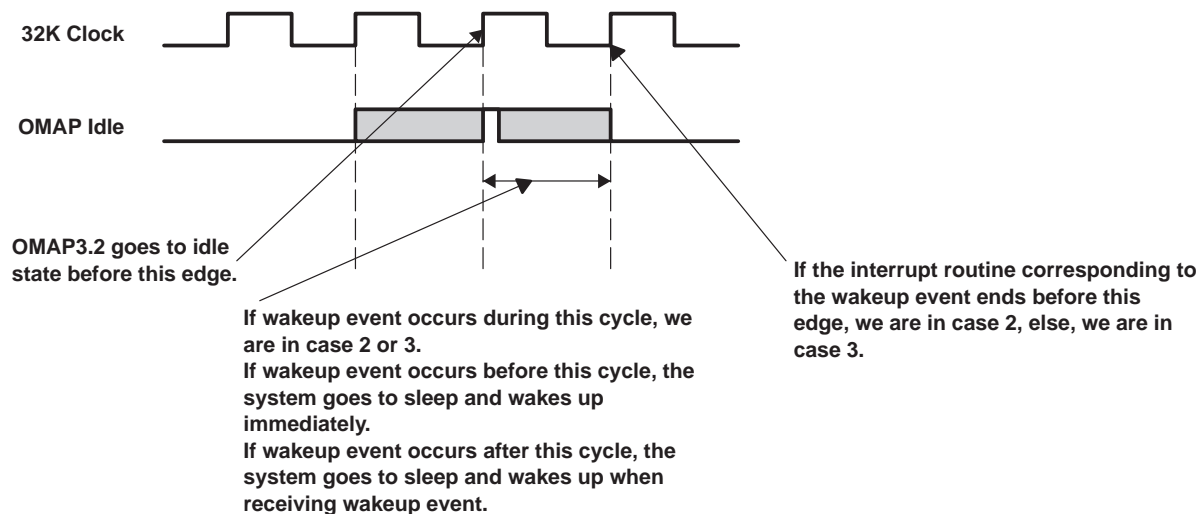
**Figure 14. IDLECT1.WKUP\_MODE = 1 Possible Effects**

1. No noticeable problem. The system wakes up correctly.
2. The OMAP3.2 clock is shut down while the ARM is awake (possibly in the middle of an instruction fetch). The wakeup event is caught, and corresponding interrupt routine has time to complete before the ARM clock is shut down. The system will go to sleep and resume normal operation on the next wakeup event (first wakeup event will be treated at this time). Depending on the time when OMAP3.2 clock was shut down, instruction/data corruption is possible.
3. The OMAP3.2 clock is shut down while the ARM is awake (possibly in the middle of an instruction fetch). The wakeup event is caught, but corresponding interrupt routine does not have time to complete before ARM clock is shut down. The system will resume normal operation. Depending on the time when OMAP3.2 clock was shut down, instruction/data corruption is possible.

Figure 14 summarizes briefly the conditions under which case 1, 2, and 3 may happen.

**Workaround:** The IDLECT1.WKUP\_MODE bit should always be 0 in all OMAP5912 devices.

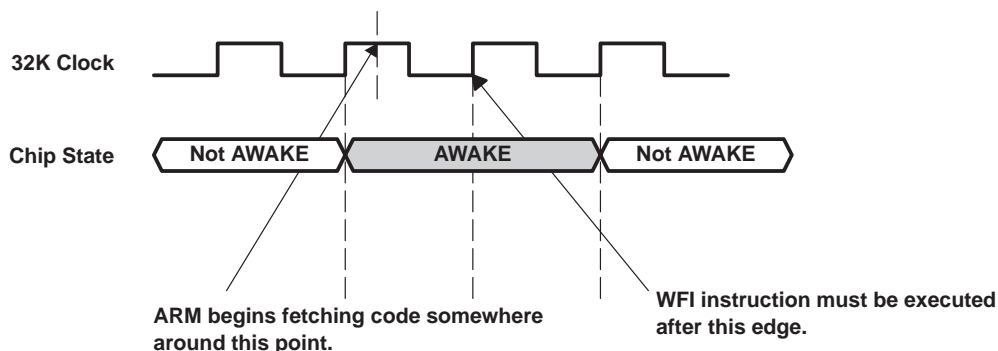
**Figure 15. Minimum AWAKE Window Needed for Proper Operation**

**Advisory  
ULPD\_4***System May Hang if Idle/Awake Sequence Period is Too Short***Revision(s) Affected:** All revisions

**Details:** When the system goes out of deep or big sleep, at least one 32K clock rising edge must occur before the WFI instruction is executed again. If this does not occur, the ULPD will stay in the awake state, and OMAP5912 will remain in idle mode. This will cause the system to hang. The only way to restore the system is to perform power-on reset or MPU reset.

**Workaround:** The Minimum AWAKE window is needed for proper operation. Software needs to make sure that one 32K clock rising edge occurs between wake up of the device and next WFI instruction execution. This can be done by monitoring 32K counter value.

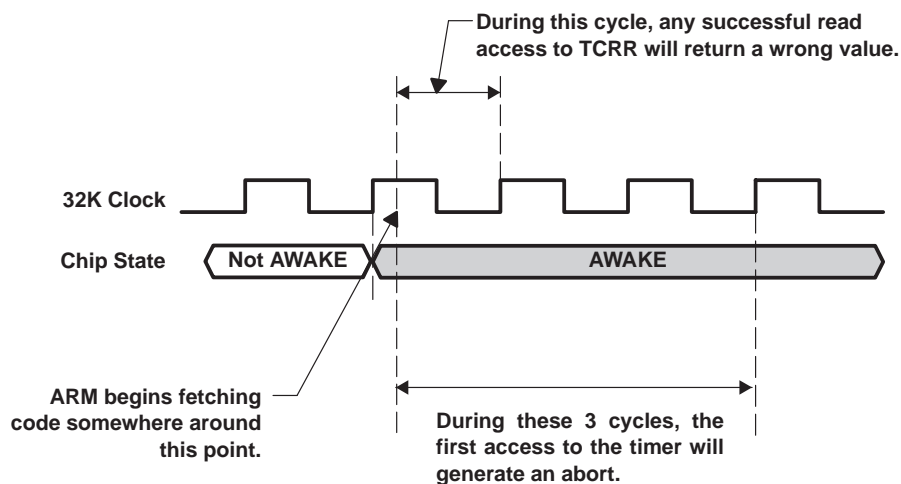
**Figure 16. DM Timer Access Timings After Wake Up From Deep Sleep (Functional Clock is 32K Clock)**

#### *After Wakeup, the First Access to Any Dual-Mode Timer May Fail*

**Details:** The following sequence of events may cause a fail on a dual-mode timer's first access:

If the dual-mode timer functional clock is configured to be a 32-kHz clock, then this time can be significantly longer than the time it takes for the MPU to do an access to the dual-mode timer. In which case, if one of the first operations software performs after wakeup is an access to dual-mode timer, then the access is very likely to fail.

**Workaround:**

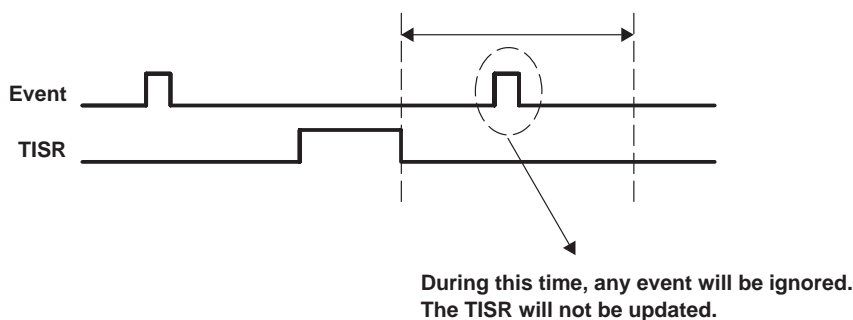
**Figure 17. DM Timer Event Ignored Window**

This problem does not occur if the event has a different type: it will be kept in the TISR.

3 Functional Clock Cycles + 3 OCP Clock Cycles

**Workaround:** There is no workaround.
