# ES\_LPC4370/50/30/20/10

Errata sheet LPC4370, LPC4350, LPC4330, LPC4320, LPC4310

Rev. 6.1 — 22 November 2013

Errata sheet

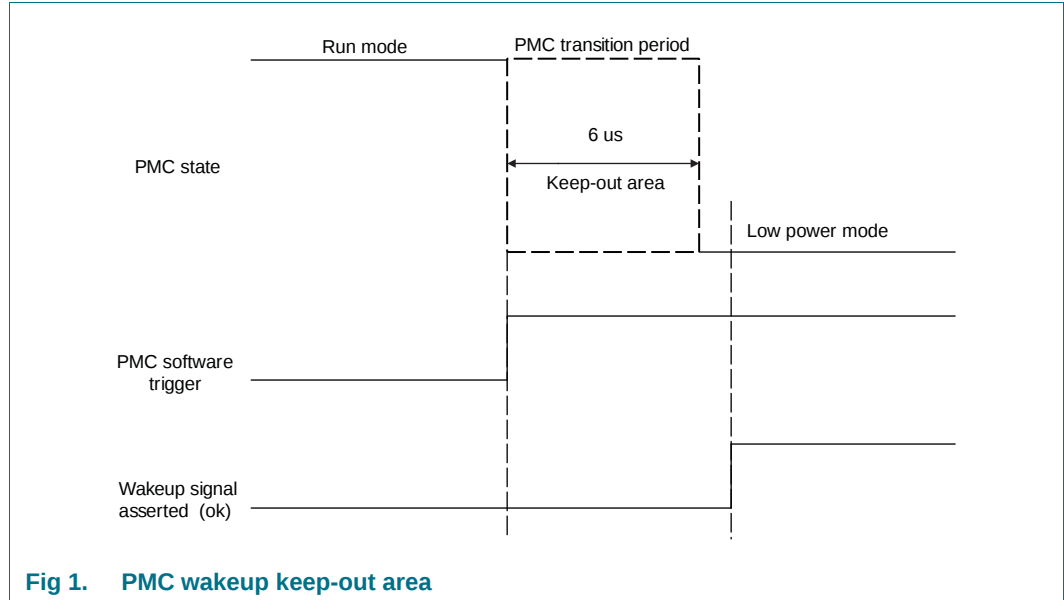
When the chip is in a transition from active to Deep Sleep, Power Down, or Deep Power Down, wakeup events are not captured and they will block further wakeup events from propagating. The time window for this transition is 6  $\mu$ S and is not affected by the chip clock speed. After a wakeup event is received during the PMC transition, the chip can only recover by using an external hardware reset or by cycling power.

Make sure that a wakeup signal is not received during the Deep Sleep, Power Down, or Deep Power Down transition period. An example circuit to work around this could include an external 6  $\mu$ S one shot which could be triggered via software using a GPIO line when entering Deep Sleep, Power Down, or Deep Power Down mode. The one-shot's output could be used to gate the wakeup signal(s) to prevent receiving a wakeup signal during the PMC transition period. Depending on the system design, it may also be needed to latch the wakeup signal(s) so that they will still be present after the one-shot's 6  $\mu$ S timeout.

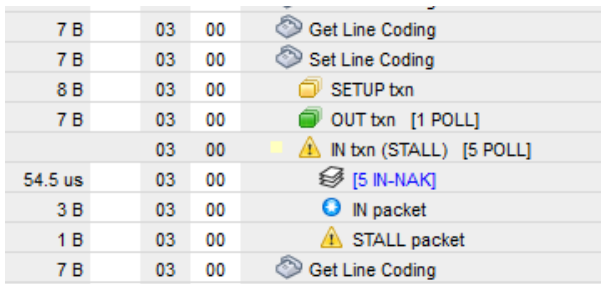
Fig 5. Incorrect

The CDC class USB ROM drivers return a STALL condition after the DATA stage of a Set Line Coding CONTROL transfer from the host. The correct behavior is to return an ACK.
