# Intel<sup>®</sup> 80303 and 80302 I/O Processors

Specification Update

*March 2007*

Order Number: 273355-011US

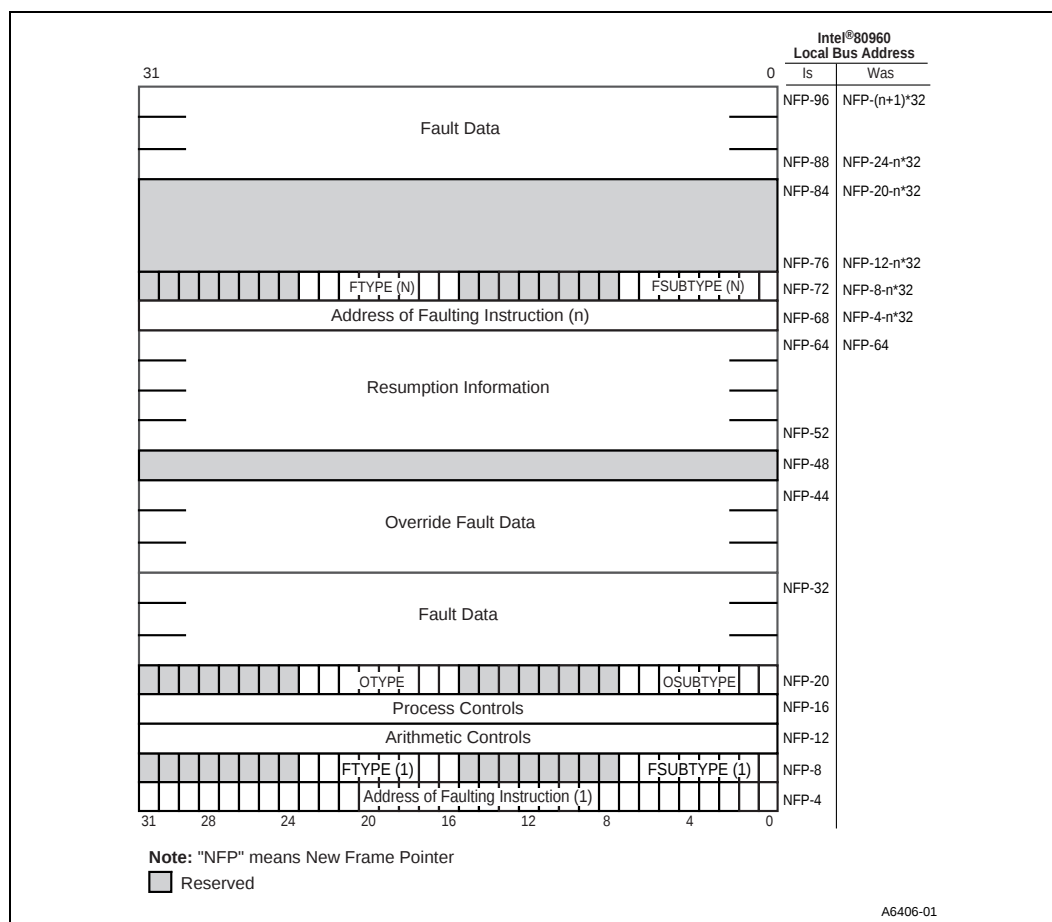
**Problem:** Figure 9-3 on page 9-9 did not print correctly.

**Workaround:** Replace Figure 9-3 with the following:

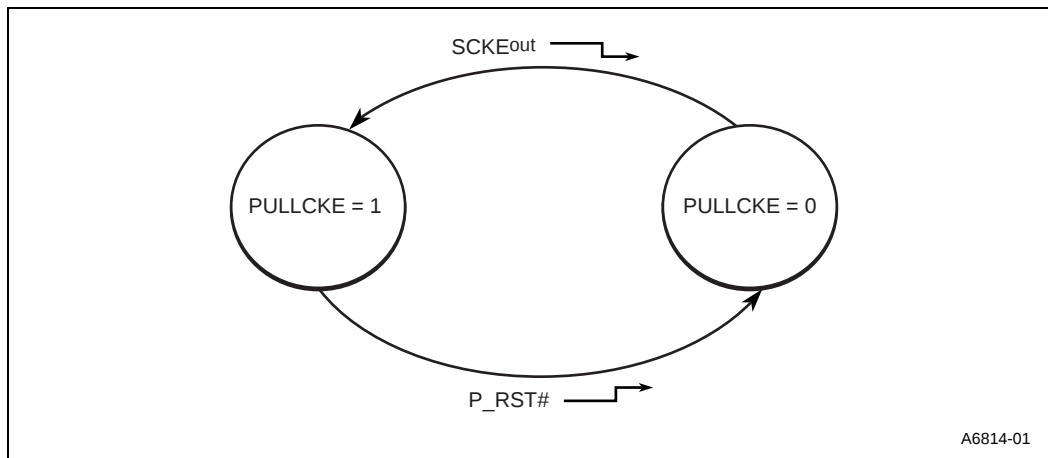
### 3. Figure 13-22 on page 13-40 did not print correctly

Problem: Figure 13-22 on page 13-40 did not print correctly.

Workaround: Replace Figure 13-22 with the following:

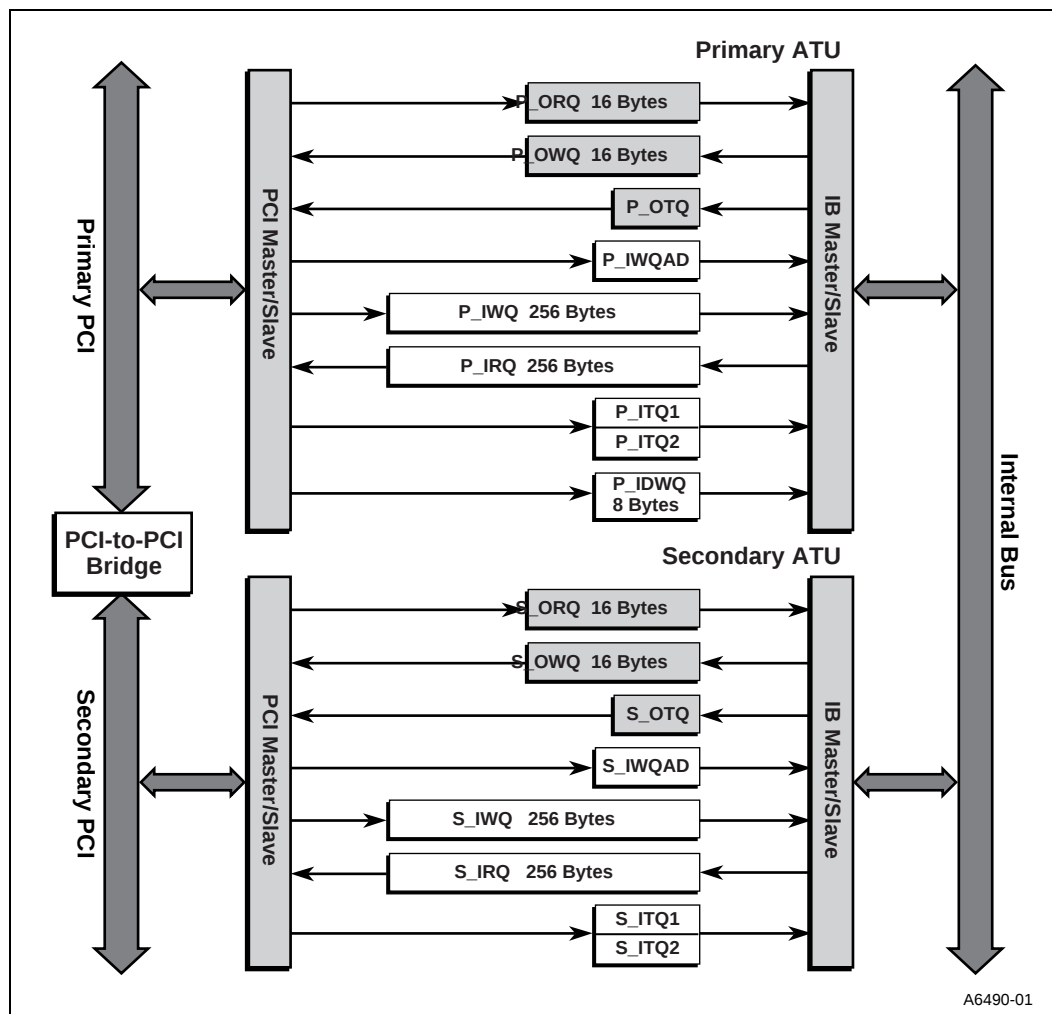
Problem: Figure 15-2 on page 15-3 did not print correctly.

Workaround: Replace Figure 15-2 with the following:

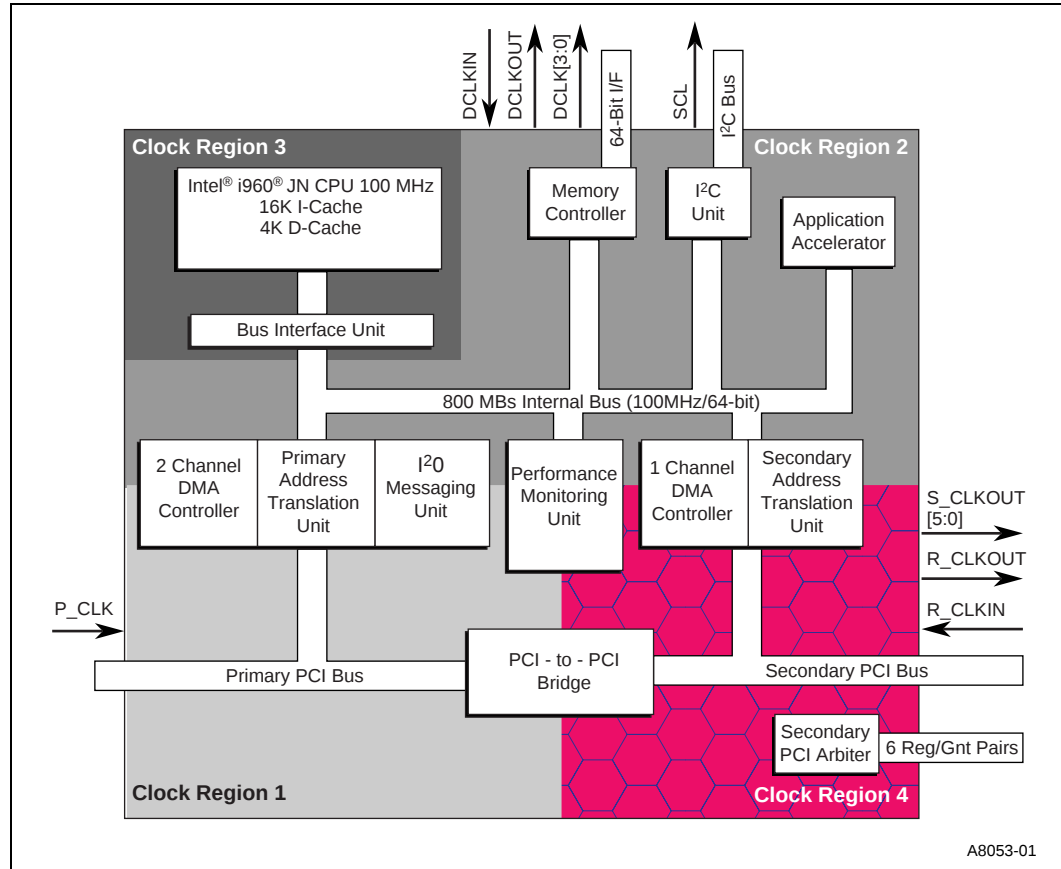
**Problem:** The Internal bus in diagram shows 66 MHz bus speed. The actual bus speed is 100 MHz

**Workaround:** Replace Figure 25-1 with the following:

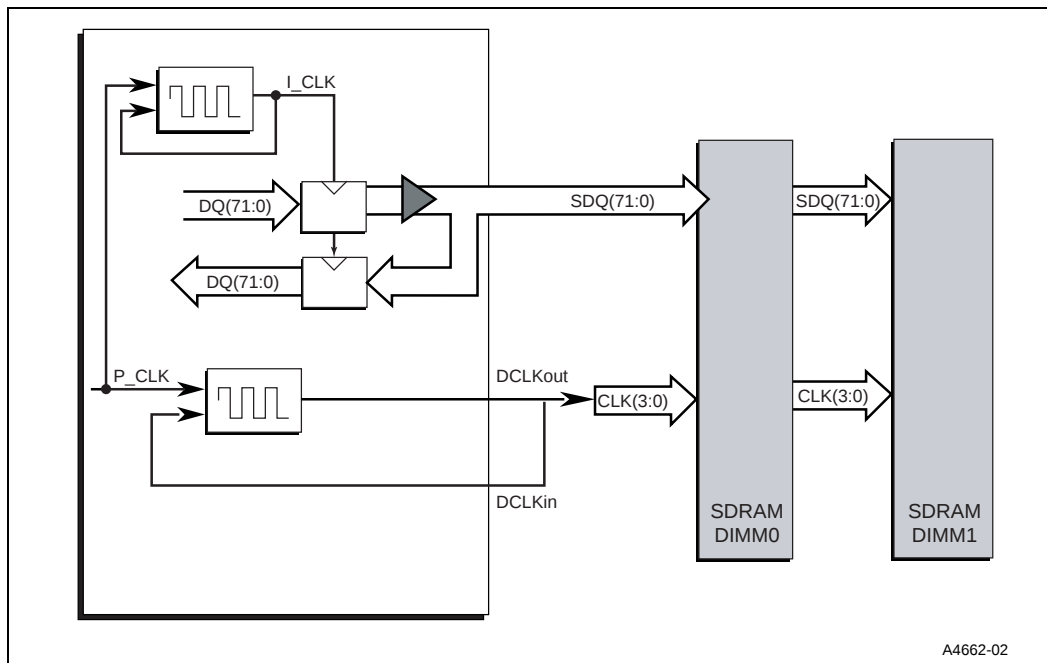
**Problem:** Figure 25-2 on page 25-2 did not print correctly.

**Workaround:** Replace Figure 25-2 with the following:

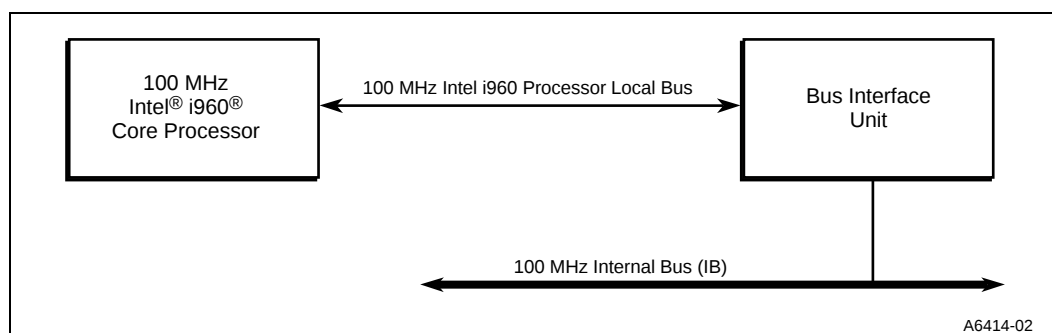
**Problem:** The Internal bus in diagram shows 66 MHz bus speed. The actual bus speed is 100 MHz

**Workaround:** Replace Figure 12-2 with the following:

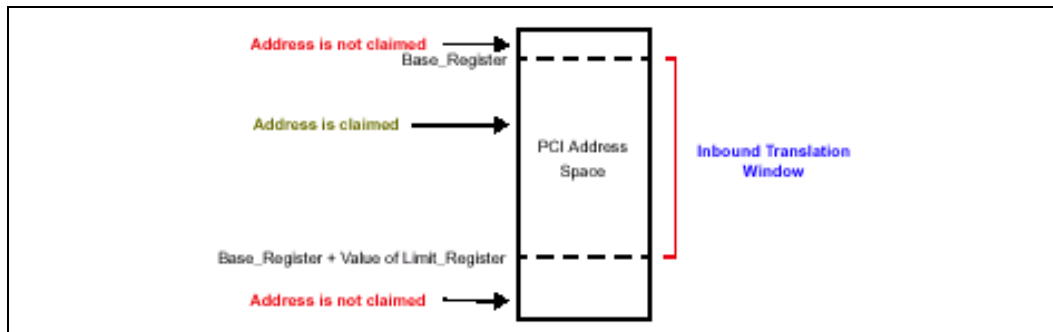
# 18. Figure 15-3 on page 15-7 has missing text

**Problem:** The figure shows 'se\_Register + Value of Limit\_Register'. It should be 'Base\_Register + Value of Limit\_Register'.

**Workaround:** Replace Figure 15-3 with the following:

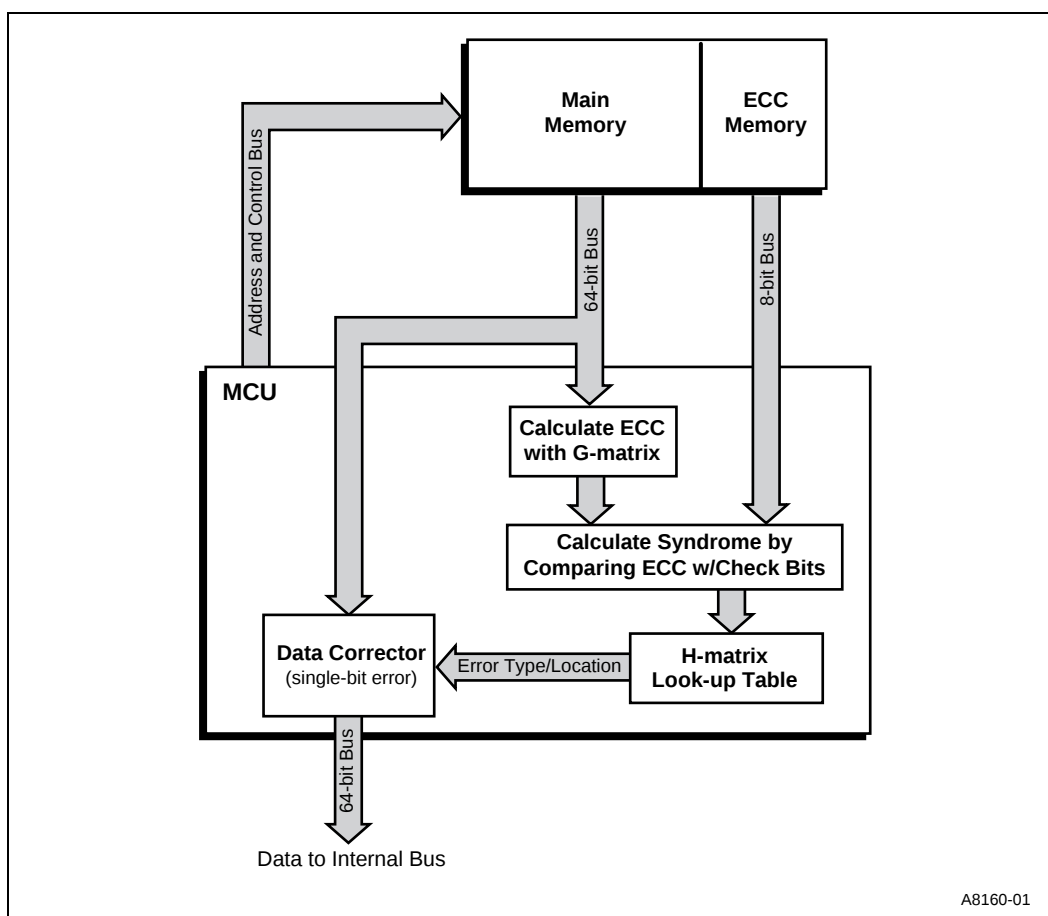
Figure 13-16 shows how the data flows through the ECC hardware for a read transaction.

**Workaround:** Replace Table 13-13 with the following and, add the adjacent paragraph with "new" Figure 13-16:

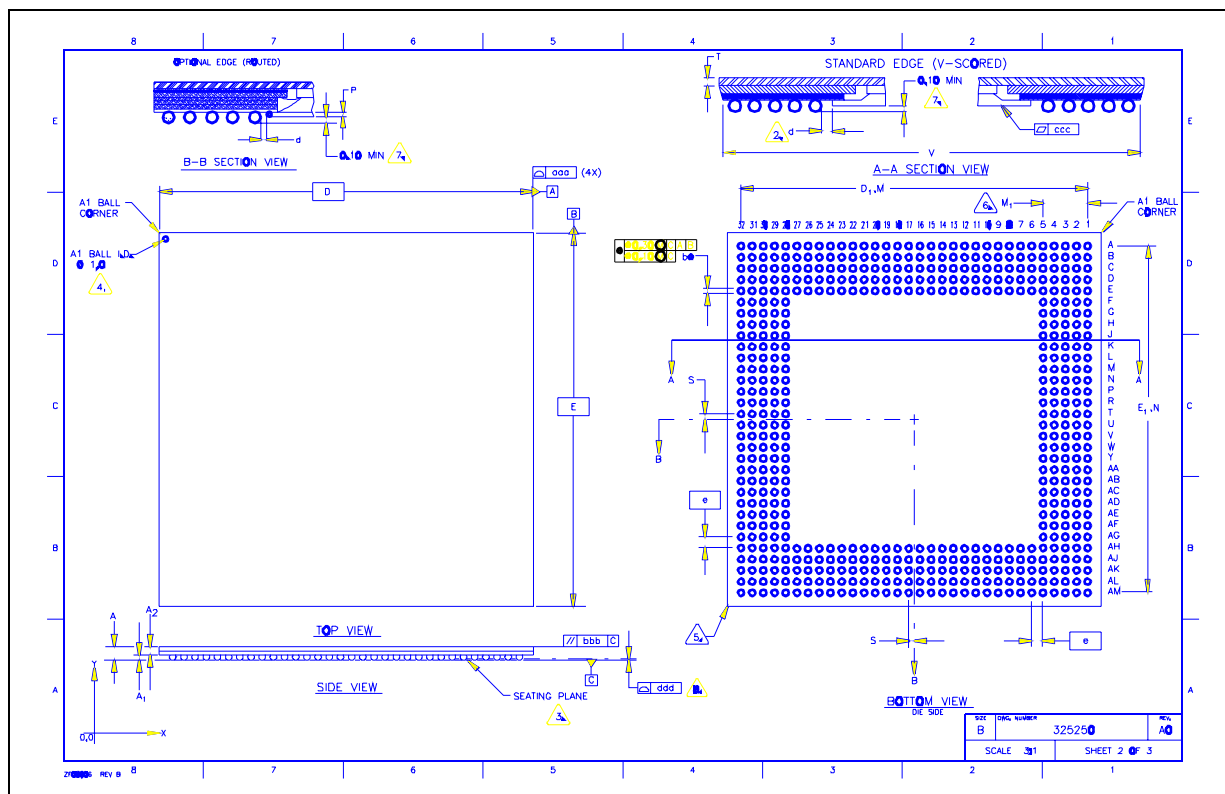
**Problem:** Product Change Notification 107318-02 describes a package change for the Intel® 80303/80302/80312 I/O processor products and lists the new order codes. The new SBGA (Super Ball Grid Array) package has the same ballout, functionality, and is still 42.5mm x 42.5mm, but the height and look of the package are different. The SBGA is a thinner package and has a full body heat spreader.
