# **OMAP5912**

## **Applications Processor**

### **Silicon Errata**

SPRZ209K  
December 2003 – Revised December 2007

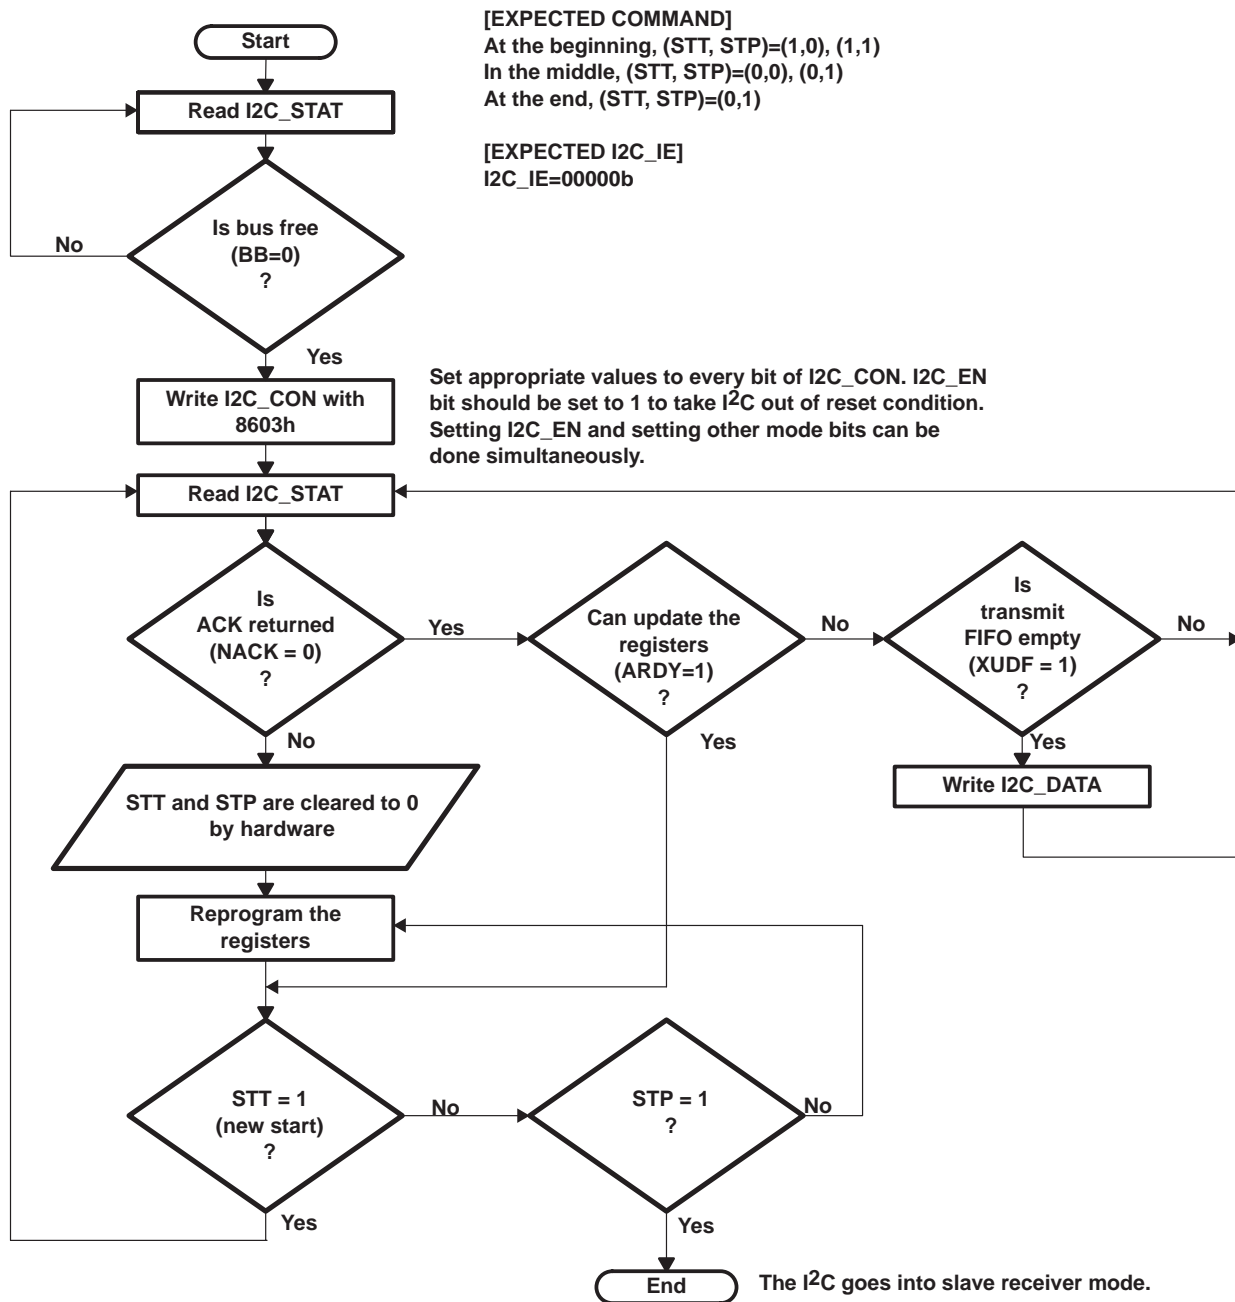
Figure 7. Master Transmitter Mode Polling Flow Diagram

*I<sup>2</sup>C Random Duplication of Byte When Sending Long Messages (Continued)*

Figure 7 and Figure 8 show the flowcharts of master transmit operation in polling and interrupt modes.

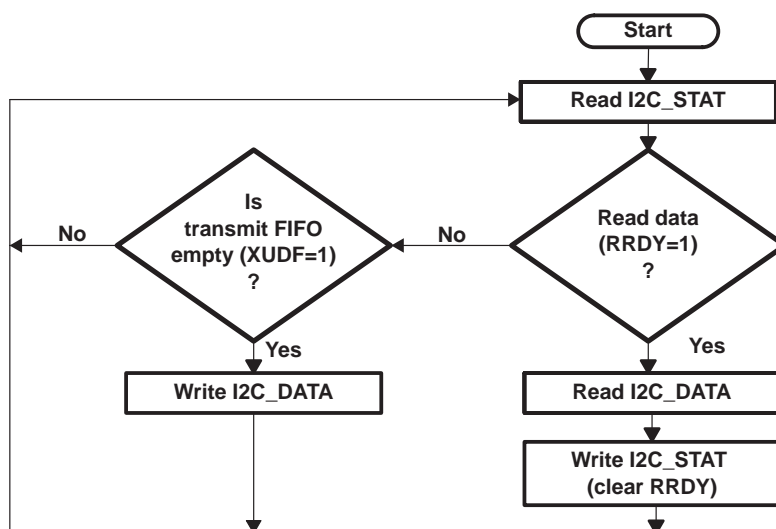
**Figure 9. Slave Transmitter/Receiver Mode Polling Flow Diagram**

*I<sup>2</sup>C Random Duplication of Byte When Sending Long Messages (Continued)*

Figure 9 and Figure 10 show the flowcharts of slave transmit/receive operation in interrupt and polling modes.

This exception will not be fixed in future silicon revisions.

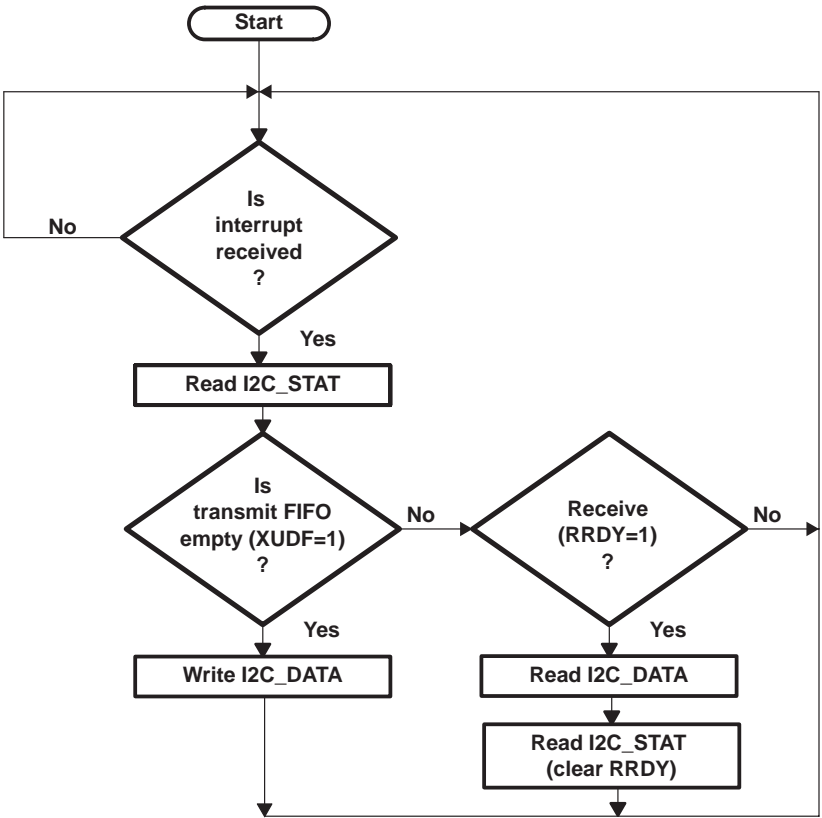
**Figure 10. Slave Transmitter/Receiver Mode Interrupt Flow Diagram**

*I<sup>2</sup>C Random Duplication of Byte When Sending Long Messages (Continued)*
