# ES\_LPC4370/50/30/20/10

Errata sheet LPC4370, LPC4350, LPC4330, LPC4320, LPC4310

Rev. 6.1 — 22 November 2013

Errata sheet

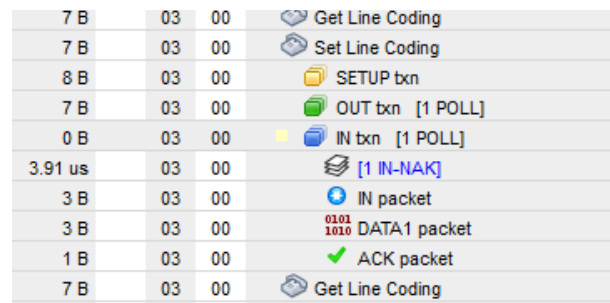
Fig 5. Incorrect

The CDC class USB ROM drivers have a bug that causes some Windows terminal emulation programs like Hyperterm to fail to connect. This bug only exists in revision 'A' parts.

The CDC class USB ROM drivers return a STALL condition after the DATA stage of a Set Line Coding CONTROL transfer from the host. The correct behavior is to return an ACK.

{
        // This code must be placed immediately after the call to
        USBD_API->cdc->init()
        USB_CORE_CTRL_T* pCtrl = (USB_CORE_CTRL_T*)UsbHandle;
        /* store the default CDC handler and replace it with ours */
        g_defaultCdcHdlr = pCtrl->ep0_hdlr_cb[pCtrl->num_ep0_hdls - 1];
        pCtrl->ep0_hdlr_cb[pCtrl->num_ep0_hdls - 1] = CDC_ep0_override_hdlr;
    }
}
```
