# Intel<sup>®</sup> I / O Controller Hub 6 (ICH6) Family

Specification Update

Order Number: 301474-030

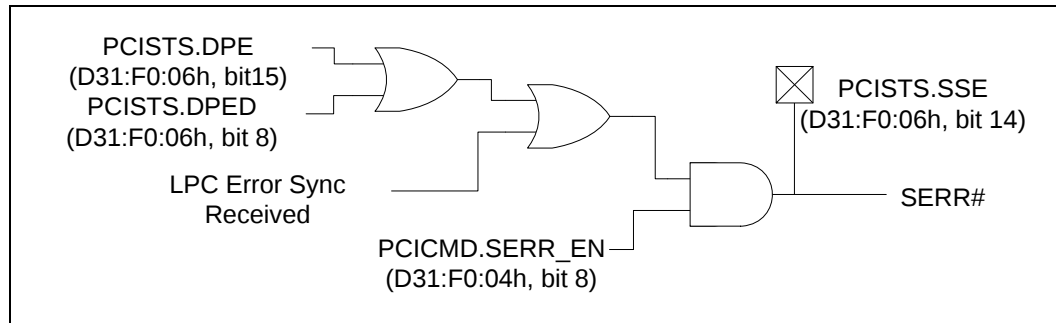
**Figure 1. LPC Bridge SERR# Generation**

Several internal and external sources of the LPC Bridge can cause SERR#, as described below.

The first class of errors is parity errors related to the backbone. The LPC Bridge captures generic data parity errors (errors it finds on the backbone) as well as errors returned on the backbone cycles where the bridge was the master and parity error response is enabled. If either of these two conditions is met, and with SERR# enable (PCICMD.SERR\_EN) set, SERR# will be captured.

Additionally, if the LPC Bridge receives an error SYNC on LPC bus, an SERR# will also be generated.
