PRO BEAM* EB Cable Plug
and Bulkhead Connector

1. INTRODUCTION

EB cable assemblies are used with the connectors shown in Figure 1. This instruction sheet covers the cleaning procedure for the endface (or lenses) of the EB insert (a component of the connector).

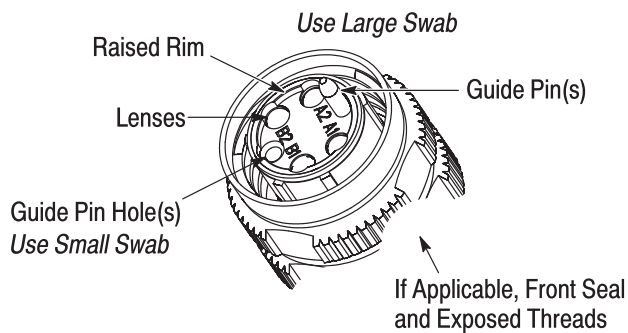
Figure 2

1. If the connector is covered with excessive dirt and debris, wash the connector with water.
2. Remove the protective cap from the connector.
3. Moisten the tip of a large swab with the isopropyl alcohol (or acetone), then using a back-and-forth or swirling motion, wipe the guide pin(s), lenses, raised rim inside of the insert, and if applicable, the front seal and any exposed threads of the connector. Refer to Figure 2.

4. Moisten the tip of a small swab with the isopropyl alcohol (or acetone), then using a back-and-forth or swirling motion, wipe the guide pin hole(s). Refer to Figure 2.
5. Blow clean dry air over the lenses until remaining solvent and stray particles are removed.

6. Inspect the lenses to make sure any contamination is removed. If necessary, repeat Steps 4 and 5 until the lenses are clean.
