Intel® 41210 Serial to Parallel PCI Bridge

Specification Update

July 2004

Document Number: 301208-003

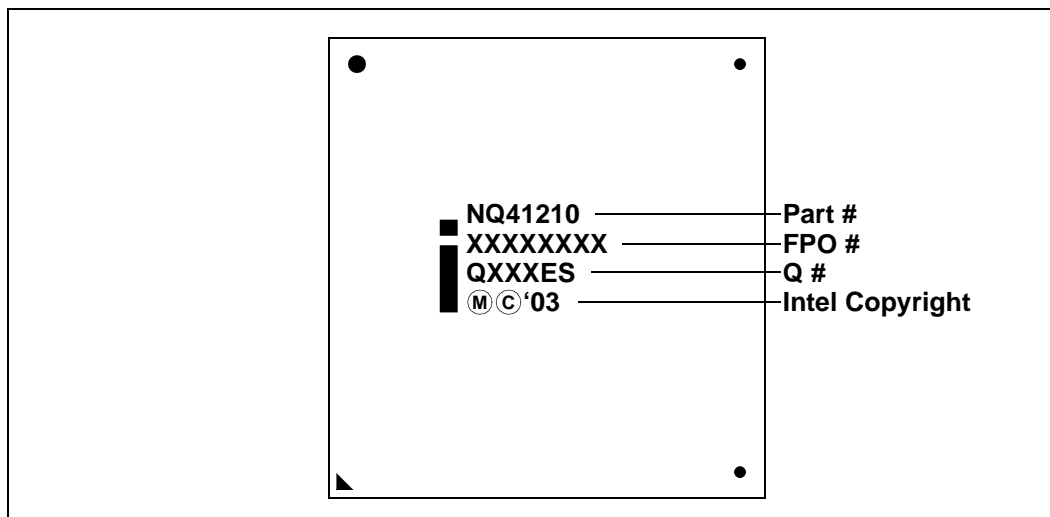
Figure 1. Marking Information

Stepping	Q Number	MM Number [†]	Notes
A1	Q645ES	857075	
B0	Q584ES	856480	
C0 with burn-in	Q718ES	858281	
C0 without burn-in	Q719ES	858282	
C1 with burn-in	Q812ES	861105	
C1 without burn-in	Q813ES	860905	
Production	SL7JE	860909
