# Intel® 80219 General Purpose PCI Processor

## Specification Update

Document Number: **274020-002**

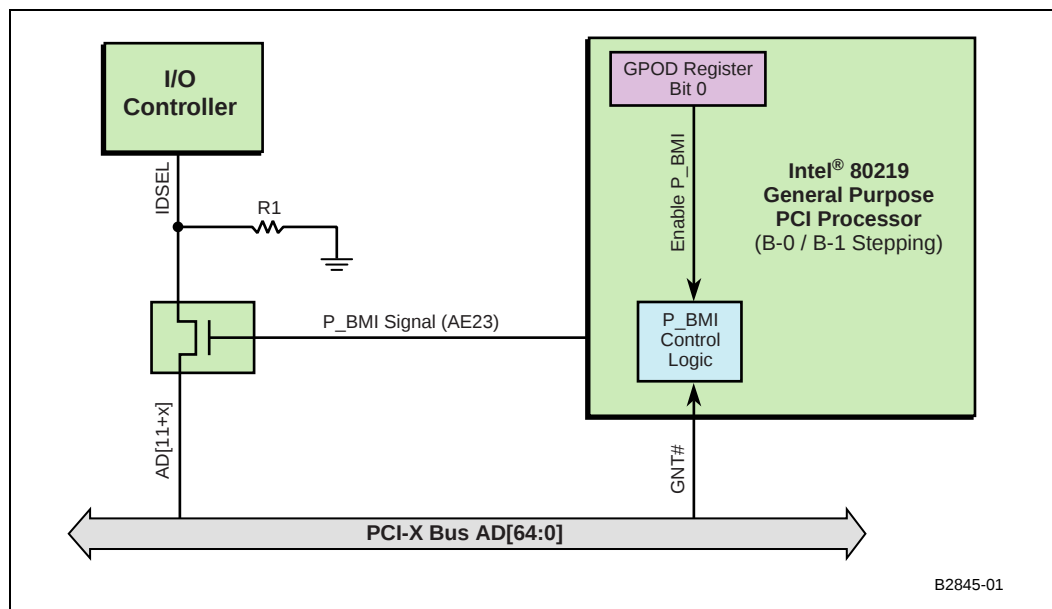
**Figure 2. Intel® 80219 General Purpose PCI Processor P\_BMI Signal Implementation for Intel® 80219 General Purpose PCI Processor B-0/B-1 Stepping**

The IDSEL signal is used as a chip select during configuration cycles initiated by the BIOS, operating system or 80219. The GPOD[0] can be driven low in firmware, thereby disabling the P\_BMI signal and hiding the host I/O device from the system, by turning off its IDSEL. When the 80219 intends to perform configuration cycles in the PCI bus segment of the I/O device, the P\_BMI signal should be asserted high by driving the GPOD[0] high. The affect of these two operations is, that the I/O device is initialized and controlled by the 80219. More care must be taken with the gate chosen to control IDSEL, since most host bridge controllers do not use PCI address stepping. With IDSEL being a synchronous signal, with respect to CLK, the switch used must be a sub nanosecond propagation delay device (e.g., Pericom PI5C3303). In Figure 2, the P\_BMI signal is used to control a MUX/DeMUX switch that is used to enable/disable IDSEL to the I/O device.
