Extended Temperature Pentium® Processor with MMX™ Technology

Advance Information Datasheet

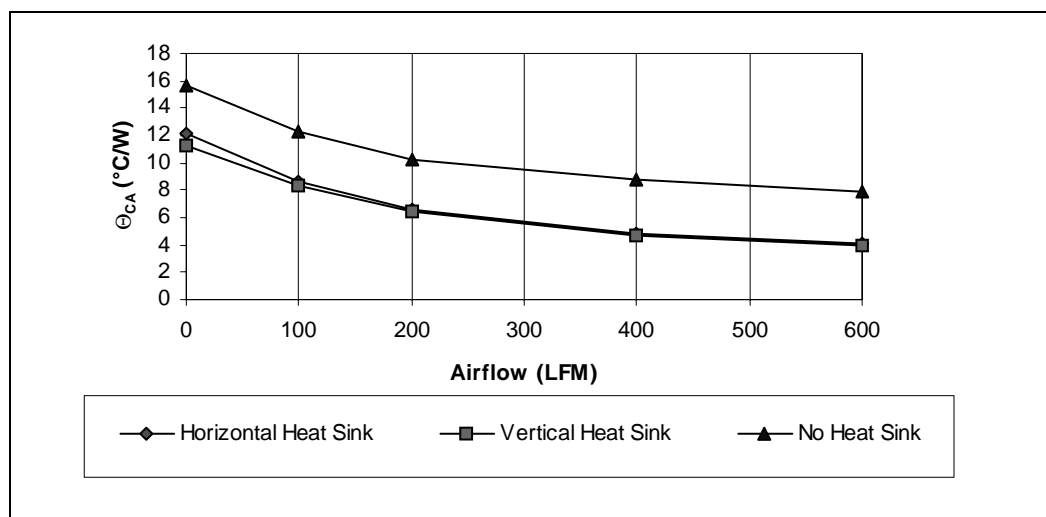
Figure 8. Thermal Resistance vs. Airflow for HL-PBGA Package

Heatsink/ Orientation	θ_{JC} (°C/watt)	θ_{CA} (°C/watt) vs. Laminar Airflow (linear ft/min)				
		0	100	200	400	600
No Heat Sink	0.76	15.66	12.33	10.3	8.85	7.89
Horizontal	0.76	12.09	8.57	6.52	4.82	4.06
Vertical	0.76	11.33	8.34	6.38	4.69	3.95

Figure 8 indicates that this example would require about 600 LFM without a heat sink, and about 150 LFM with a heat sink in the vertical orientation.

Figure 8 indicates that this example would require about 200 LFM without a heat sink, and about 25 LFM with a heat sink in vertical orientation, for typical power and 85° C ambient conditions.
