REV.  
D

SML-LX15USBC-RP-TR

SOT-23 REPLACEMENT, SURFACE MOUNT LED,  
470nm ULTRA SUPER BLUE LED, REVERSE POLARITY,  
WATER CLEAR LENS, TAPE AND REEL

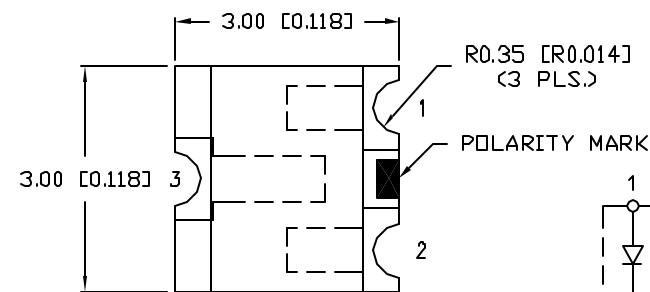
TOTAL TIME ABOVE 220°C IS 60 SECONDS MAX.

OUR MANY YEARS OF EXPERIENCE DATA ACCUMULATION INDICATE THAT SOLDER HEAT IS A MAJOR CAUSE OF EARLY AND FUTURE FAILURE. PLEASE PAY ATTENTION TO YOUR SOLDERING PROCESS.

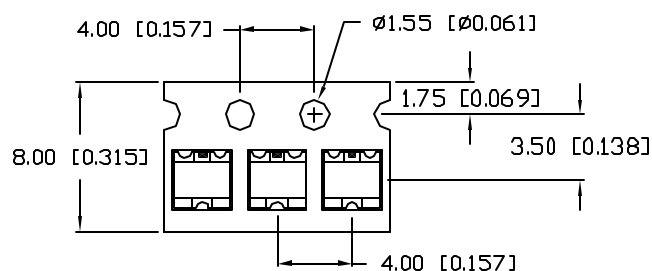
## TAPE SPEC. DETAIL

TAPE FEED DIRECTION →

1. THE POLARITY MARK IS ORIENTED TOWARDS THE TAPE SPROCKET HOLE.
